Homerit www.homerit.co.nz

Recessed Installation Details

Figure R1 Ver: 1.2 Nov 2024

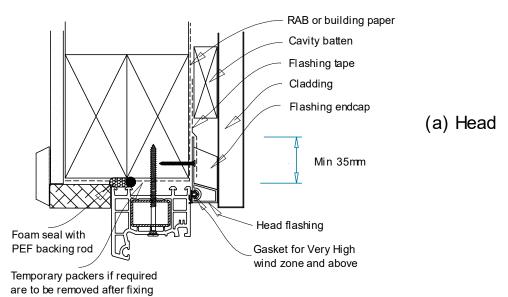
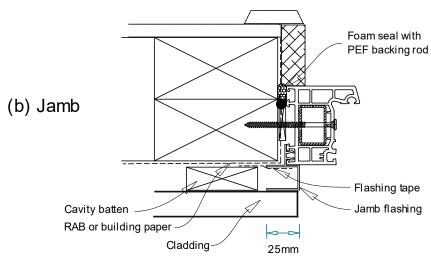
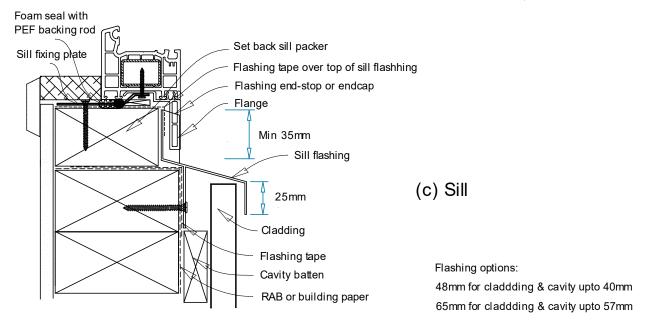
-- Head & jamb flashings behind cladding
